Subject: LER -2005-001-00 [Reactor Scram 109 on
February 11, 2005, Due To Loss Of Service Transformer 11]

Grand Gulf Nuclear Station, Unit 1
Docket No. 50-416
License No. NPF-29

LICENSEE EVENT REPORT (LER)

Reactor SCRAM Due to Loss of Service Transformer 11 Caused By Animal Intrusion

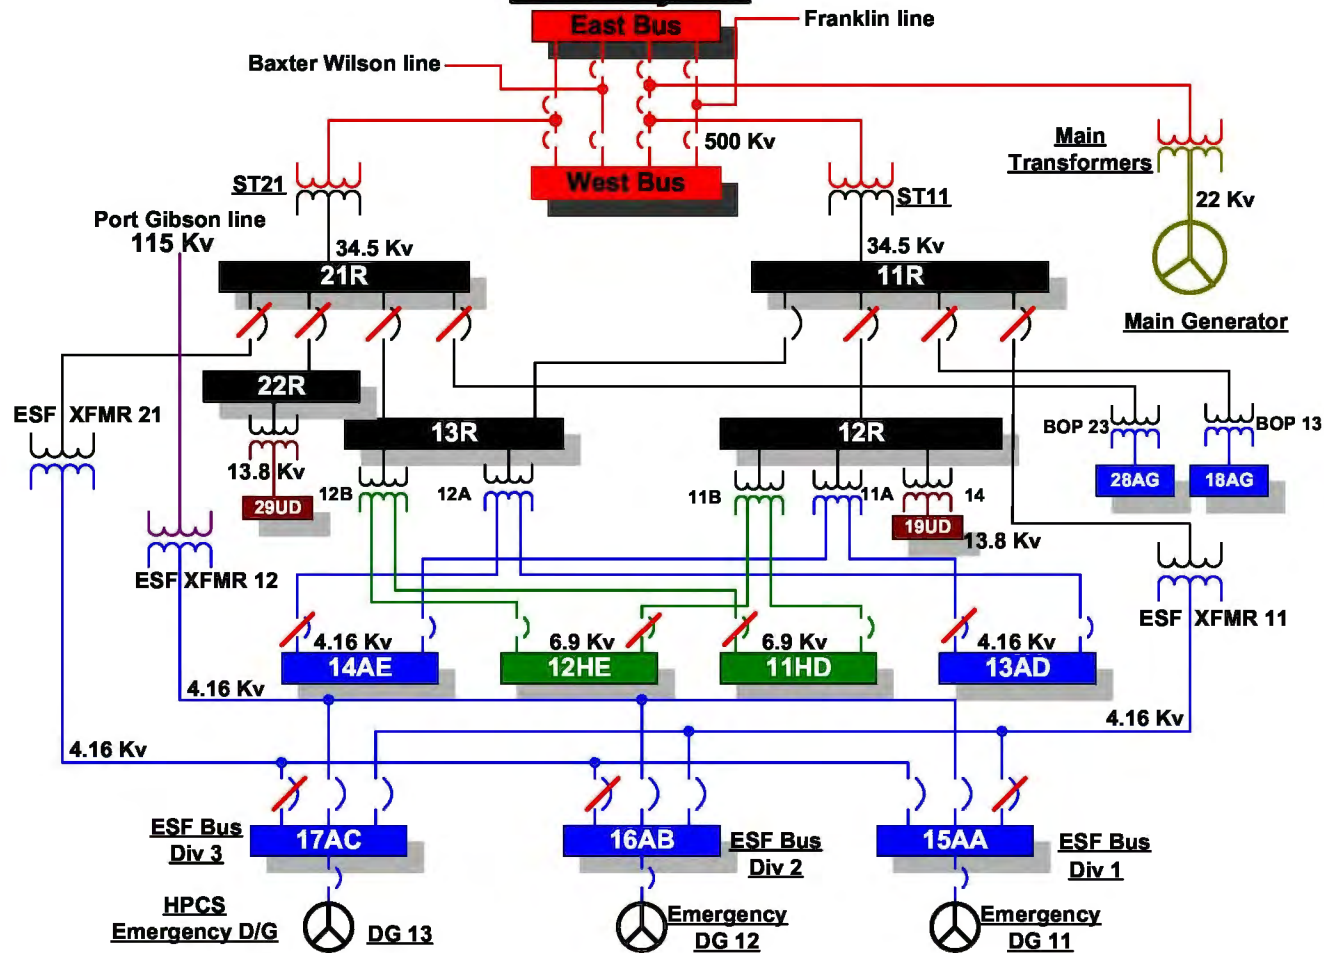
Attachment 1 - GGNS Distribution Switchyard.

The ground fault was the result of an animal intrusion which resulted in a bridging of the 34.5 kV bus work of Service Transformer ST11. A dead raccoon was found with indications that it had shorted two phases. Upon entry of the 34.5 kV switchyard, it was discovered that the animal intrusion fence had been de-energized via the "On/Off" switch. It could not be determined how long this condition had existed.

Immediate Corrective Actions - An inspection of the animal intrusion fence (electrified) was added to the daily Operations rounds to ensure the fence remains energized. A lock was added to the gate enclosing the affected breaker.
